KOOTENAI DEVELOPMENT IMPOUNDMENT DAM

ANNUAL OWNERS INSPECTION REPORT

BILLMAYER ENGINEERING

MAY 23, 2007

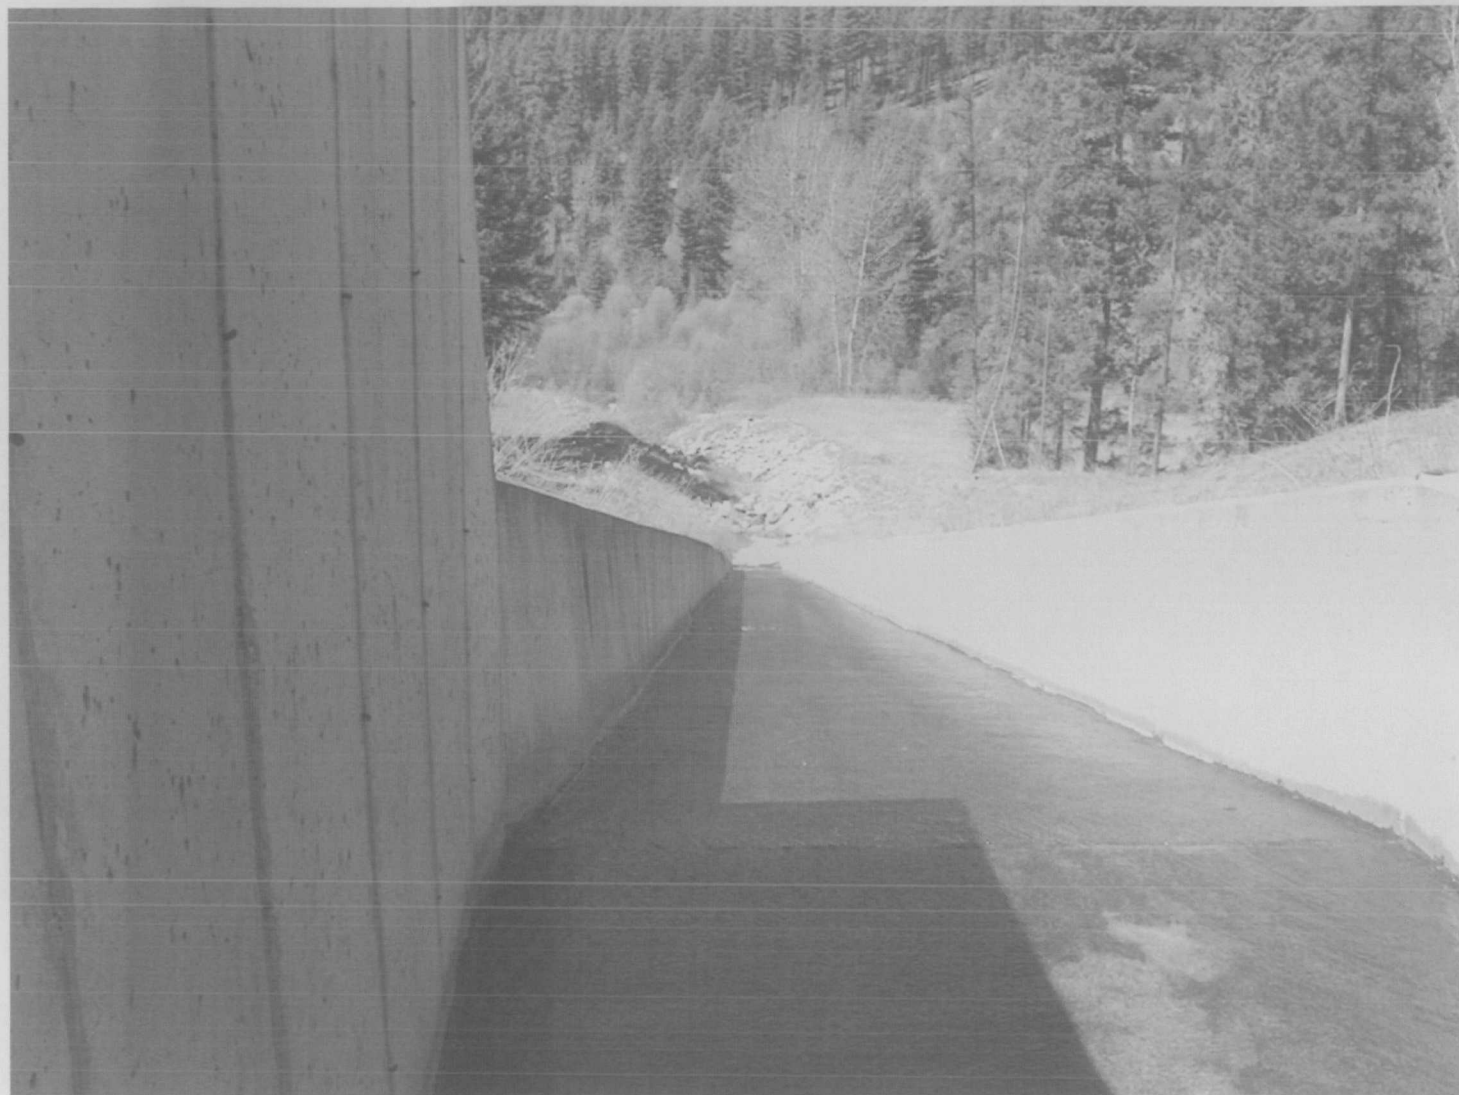
E3-27

It was noted in the field inspection that the bottom of the walls at the wall to floor joint tended to fluctuate in and out but it was determined that these were construction defects and were not from settlement or deflection after construction. This defect was noted in most of the wall sections.

LEFT SIDE OF STEEP SECTION OF OPEN CHUTE SPILLWAY, NOTE CONSTRUCTION WOBBLES AT WALL TO FLOOR JOINT

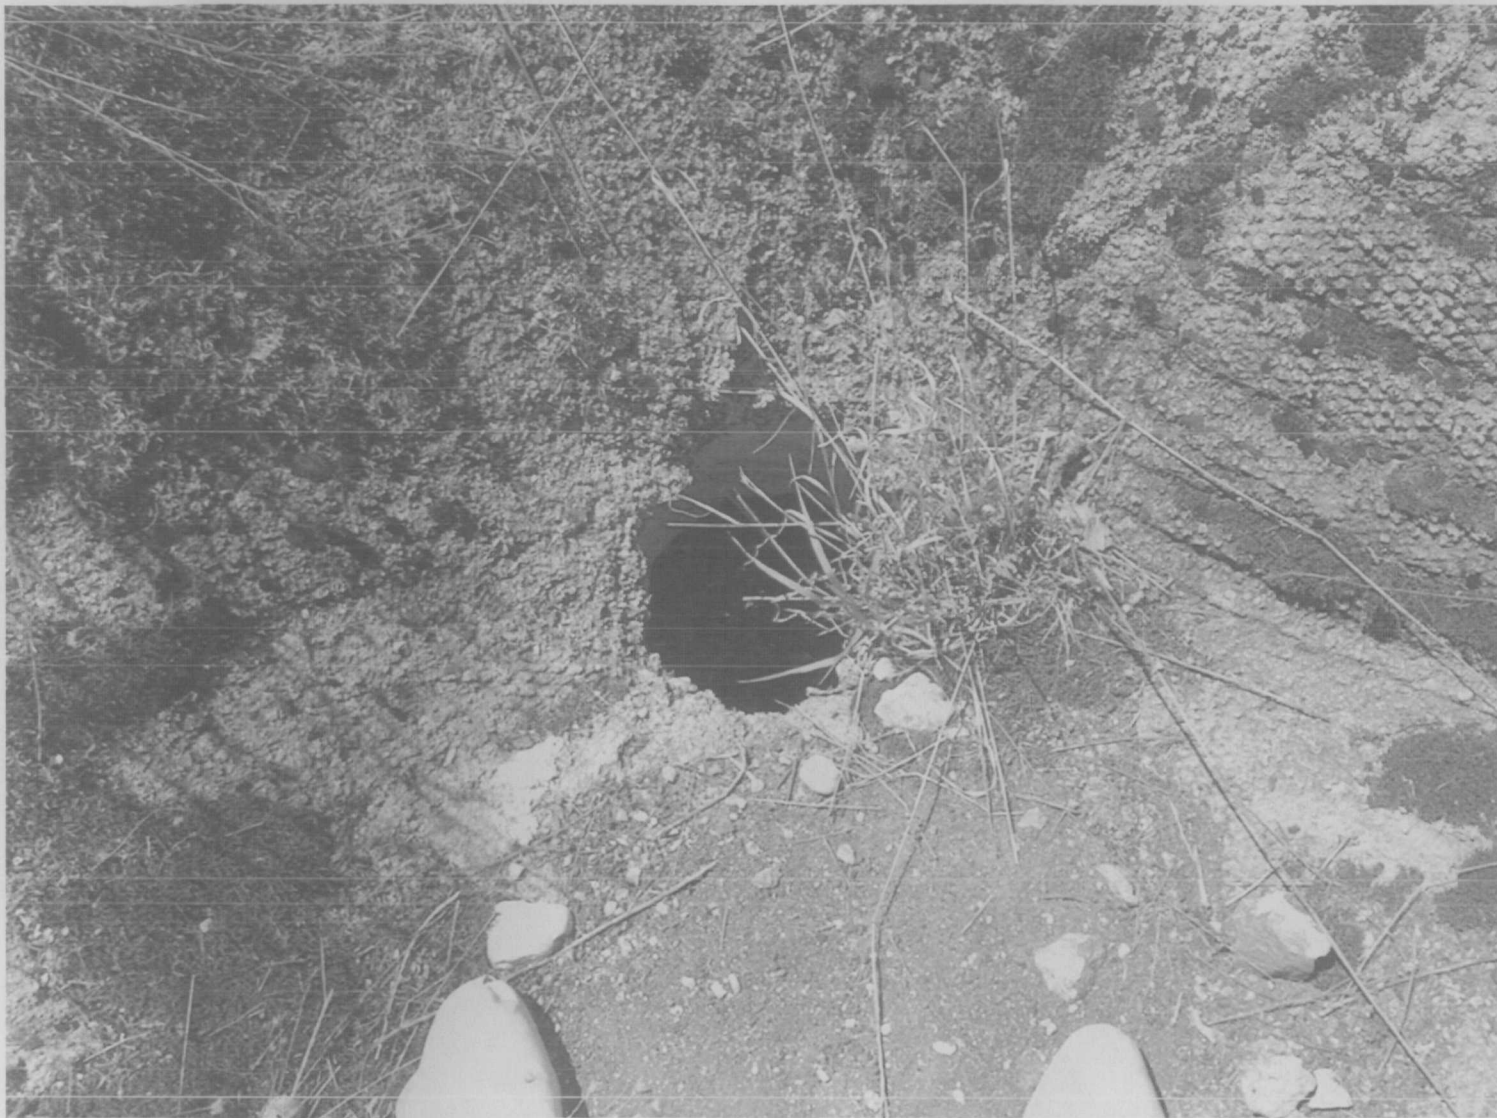
The downstream face was inspected by walking each of the lift lines on the face. There was no misaligned sections, no bulges, cracks or significant erosion noted anywhere on the downstream face. There are some small cottonwood trees growing on the face of the first lift as shown on page E3-32. There is also one small erosion channel noted on the top of the first lift adjacent to the left groin as shown on page E3-33. The erosion may be associated to a drain that is also located in the left groin on top of the lift just to the left of the erosion channel and may have been caused by possible plugging of the open drain. The entrance to the drain is shown on page E3-31. As shown

in the photograph, the drain does not have a grate on the top and it was assumed that the drain might plug with debris and from time to time that may cause water to run down the face of the first lift but there were no clear signs that the two areas are directly related.

OPEN DRAIN NEAR THE LEFT GROIN ON TOP OF LIFT #1

Downstream Face: The downstream face is in good to excellent condition. The small cottonwoods shown in photograph E3-32 should be removed before the fall of 2008. The drain shown in photograph E3-31 should be cleaned around the edges so that trash and debris can easily move through the entrance. A top hat grate may need to be installed to keep debris out of the culvert. A picture of a top hat grate is shown on page E5-8. It should be inspected each time someone is on site to be sure it is free flowing.

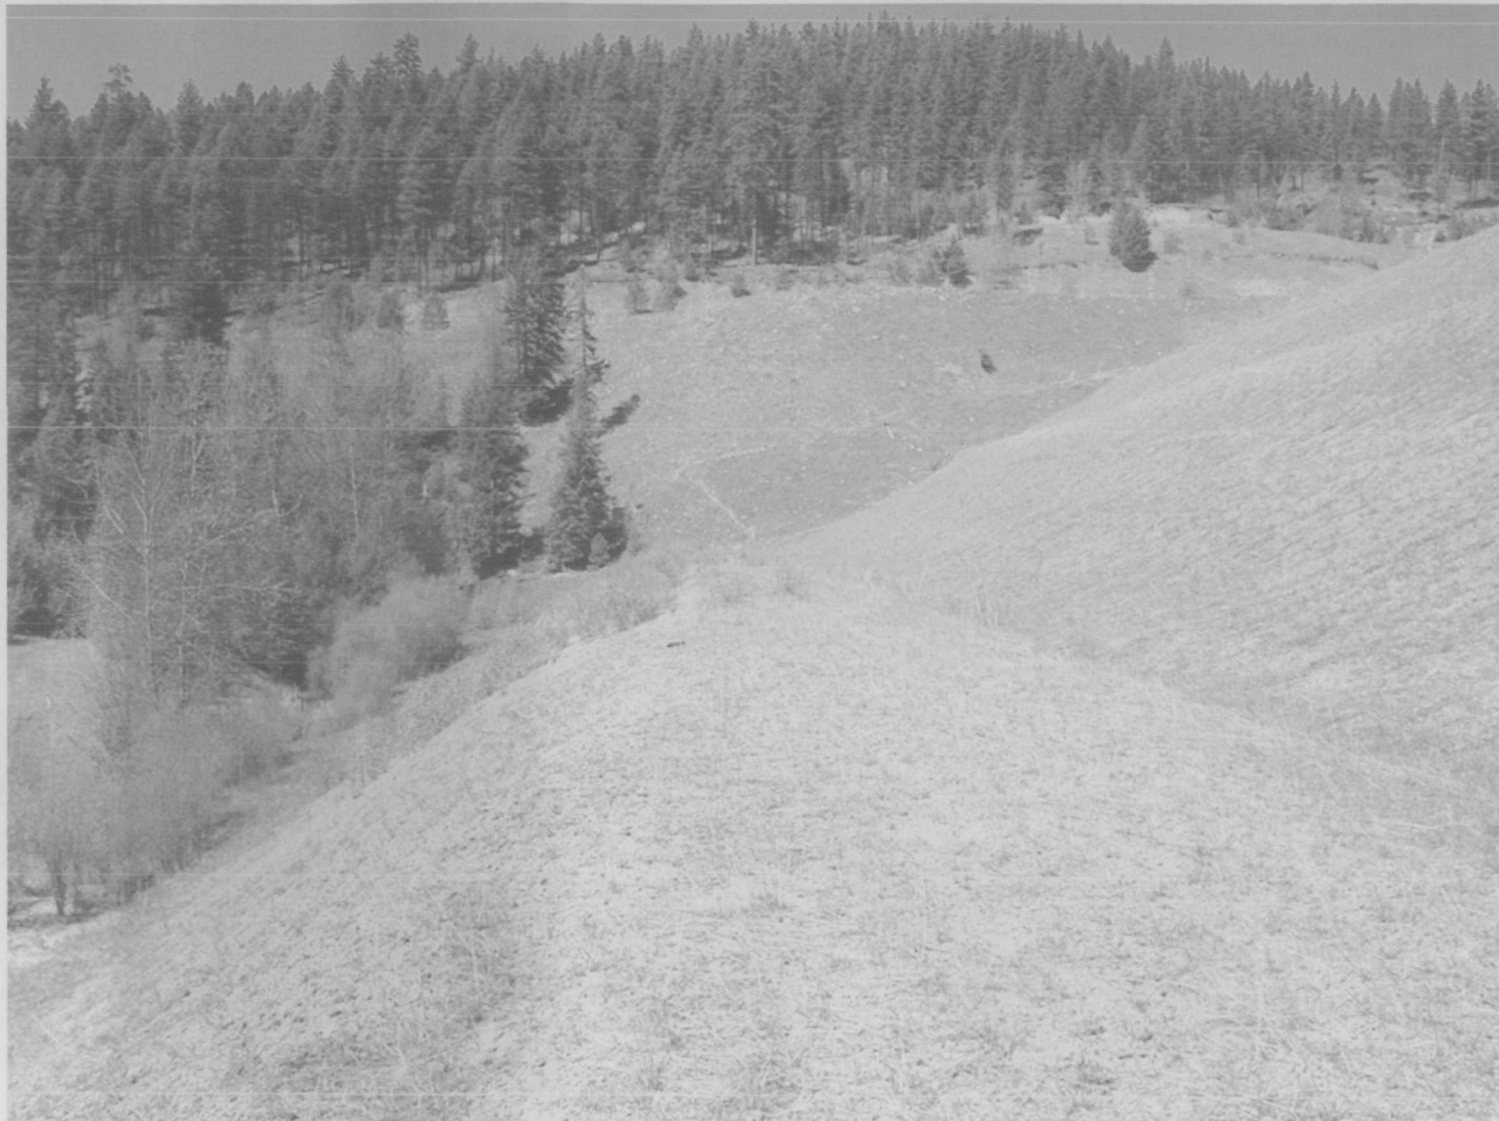
E3-32

TOP OF LIFT#1 LOOKING NORTHWEST, NOTE SMALL COTTONWOODS

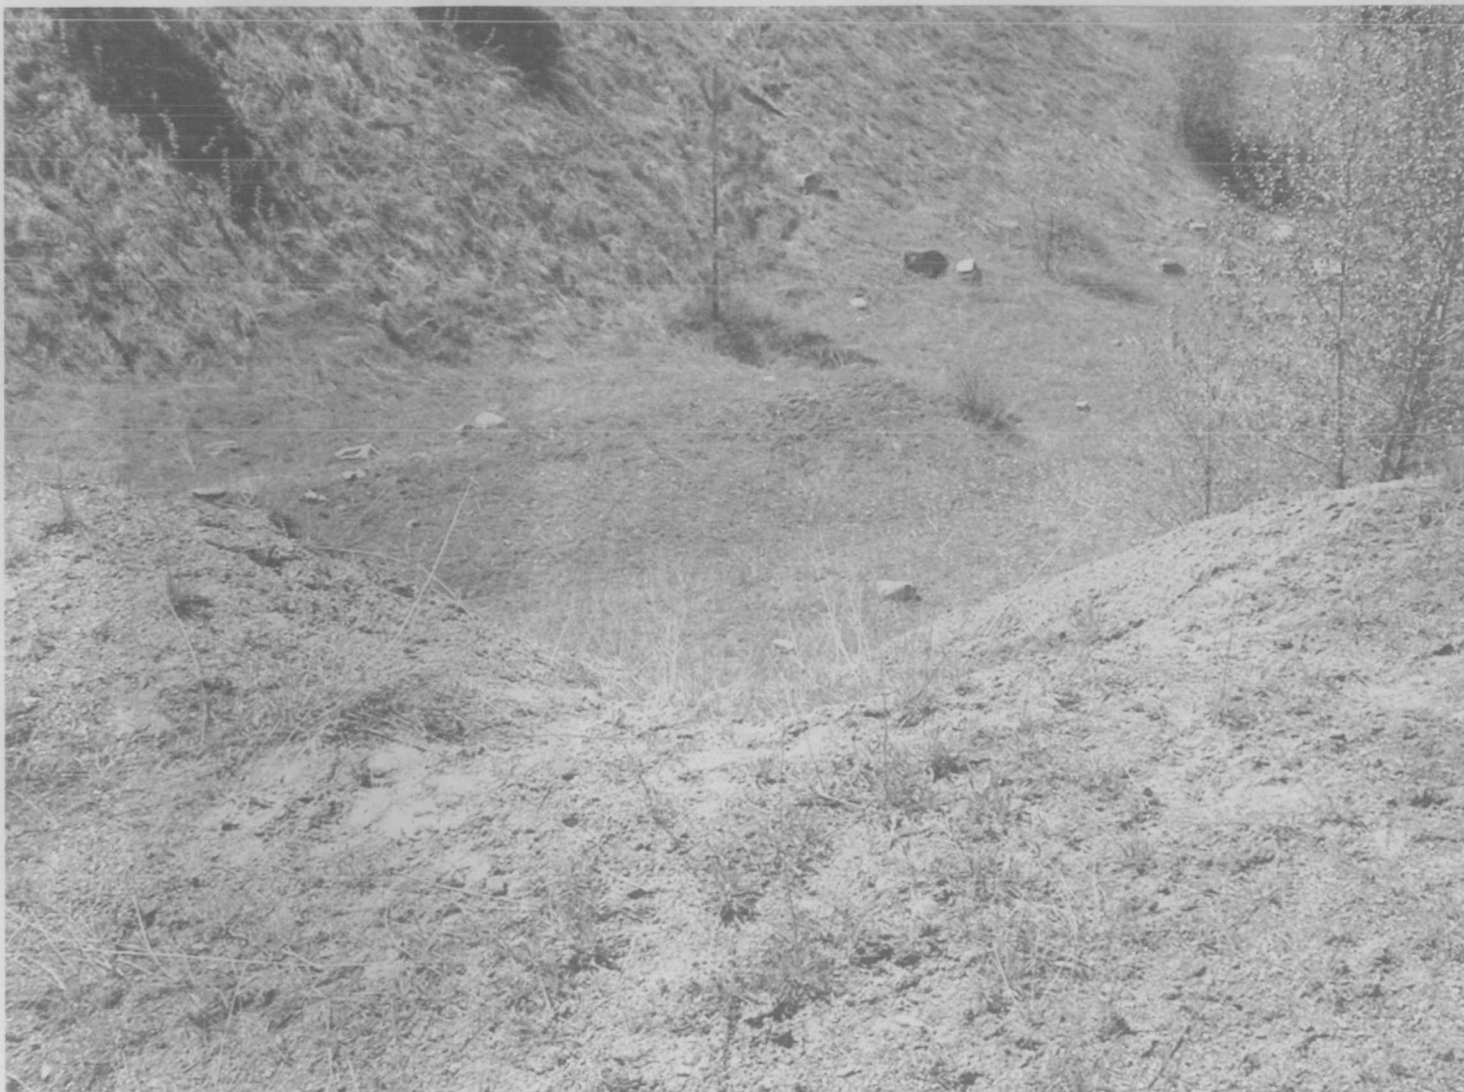
E3-33

POSSIBLE EROSION CUT NEAR LEFT SIDE DRAIN, ON TOP OF LIFT #1

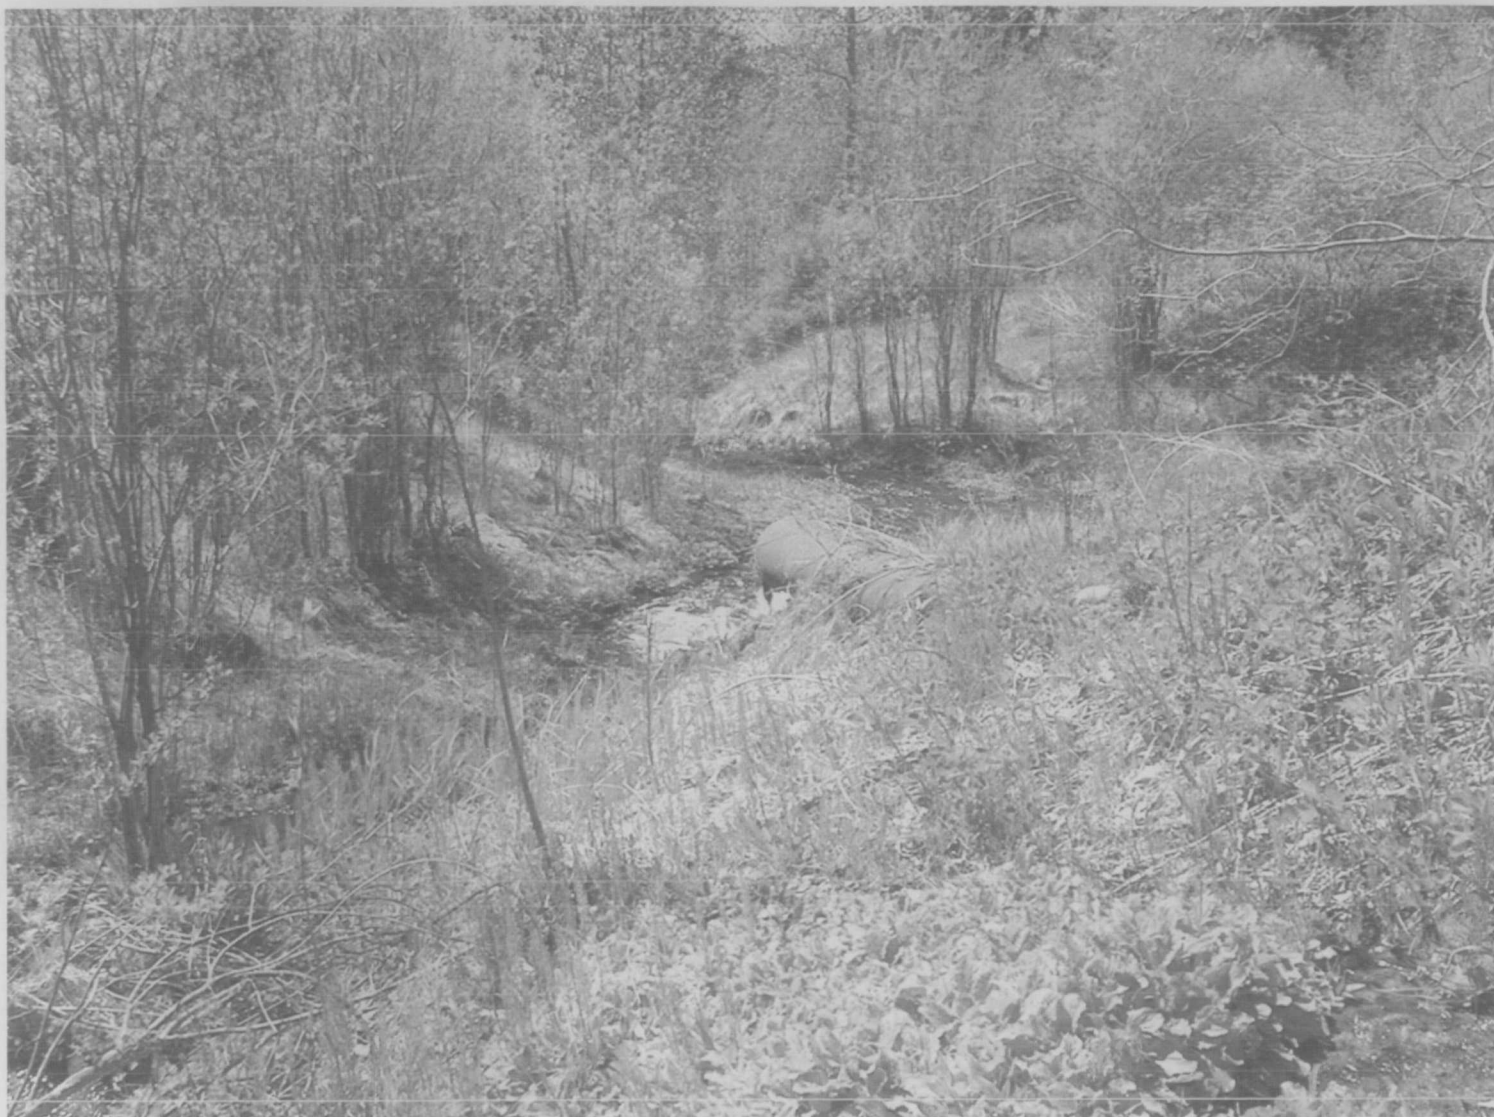
E3-37

12-inch steel pipe projecting from face of the embankment approximately 3 feet, near the center of the embankment. The pipe was running water and the depth of the water was measured at 0.21 feet deep. A calculation of the flow using Flowmaster® was 340 gpm. A copy of the Flowmaster® data is shown in Exhibit 4 page E4-1. The pipe had a free discharge into the channel below the pipe. No flow was noted around the outside of the pipe. A photograph of the pipe is shown on page E3-37.

FLOW FROM THE 12-INCH STEEL PIPE DRAIN NEAR CENTER OF THE EMBANKMENT TOE

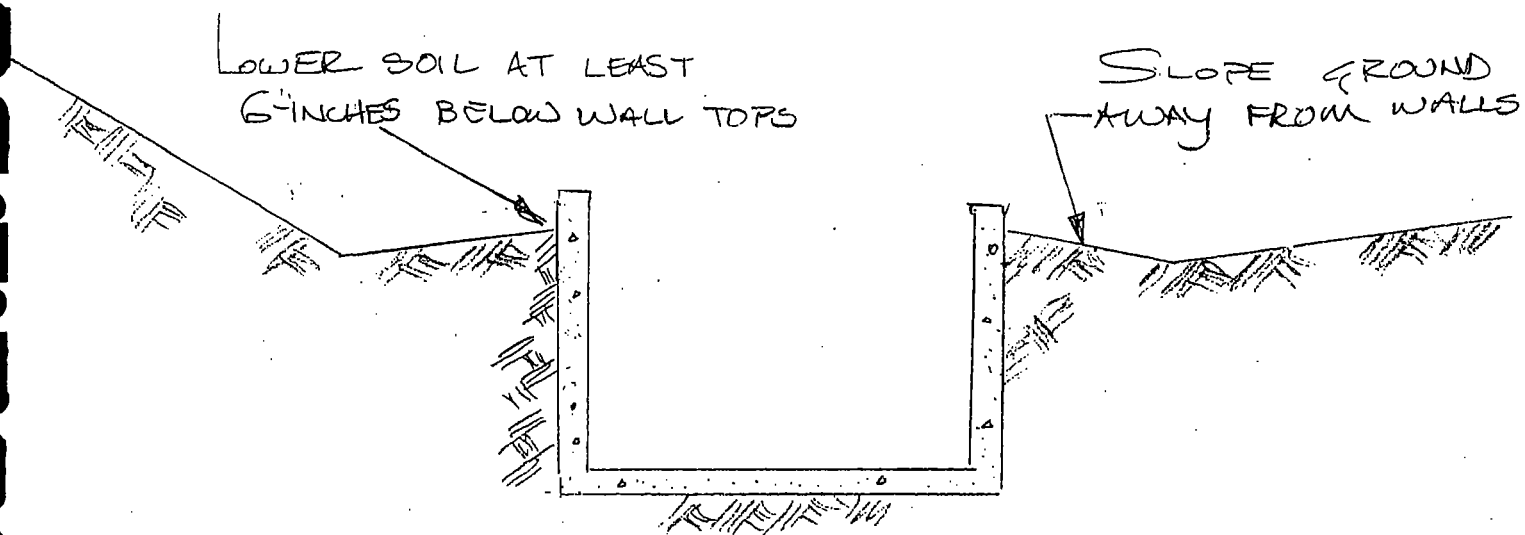
KOOTENAI IMPOUNDMENT DAM
OPEN CHUTE SPILLWAY REGRADING PLAN

Open Chute: The earth next to the open chute spillway should be re-graded so that the wall tops are above the local grade at least 3 to 4 inches so that water will not collect on the wall tops and that weeds and plants that grow next to the walls have less of a chance to hold moisture on the wall tops and allow freeze thaw damage to occur. The ground next to the wall tops should be re-graded so that water flows away from the walls rather than toward the walls and down the sides. A sketch of the grading is shown on page E5-7. This project should be completed before the fall of 2008.
